Field Report for Airborne Data Collected In Support of US EPA Region 6 Intercontinental Terminals Company LLC Fire 14 April 2019

Data Results Flight 25, 14 April 2019

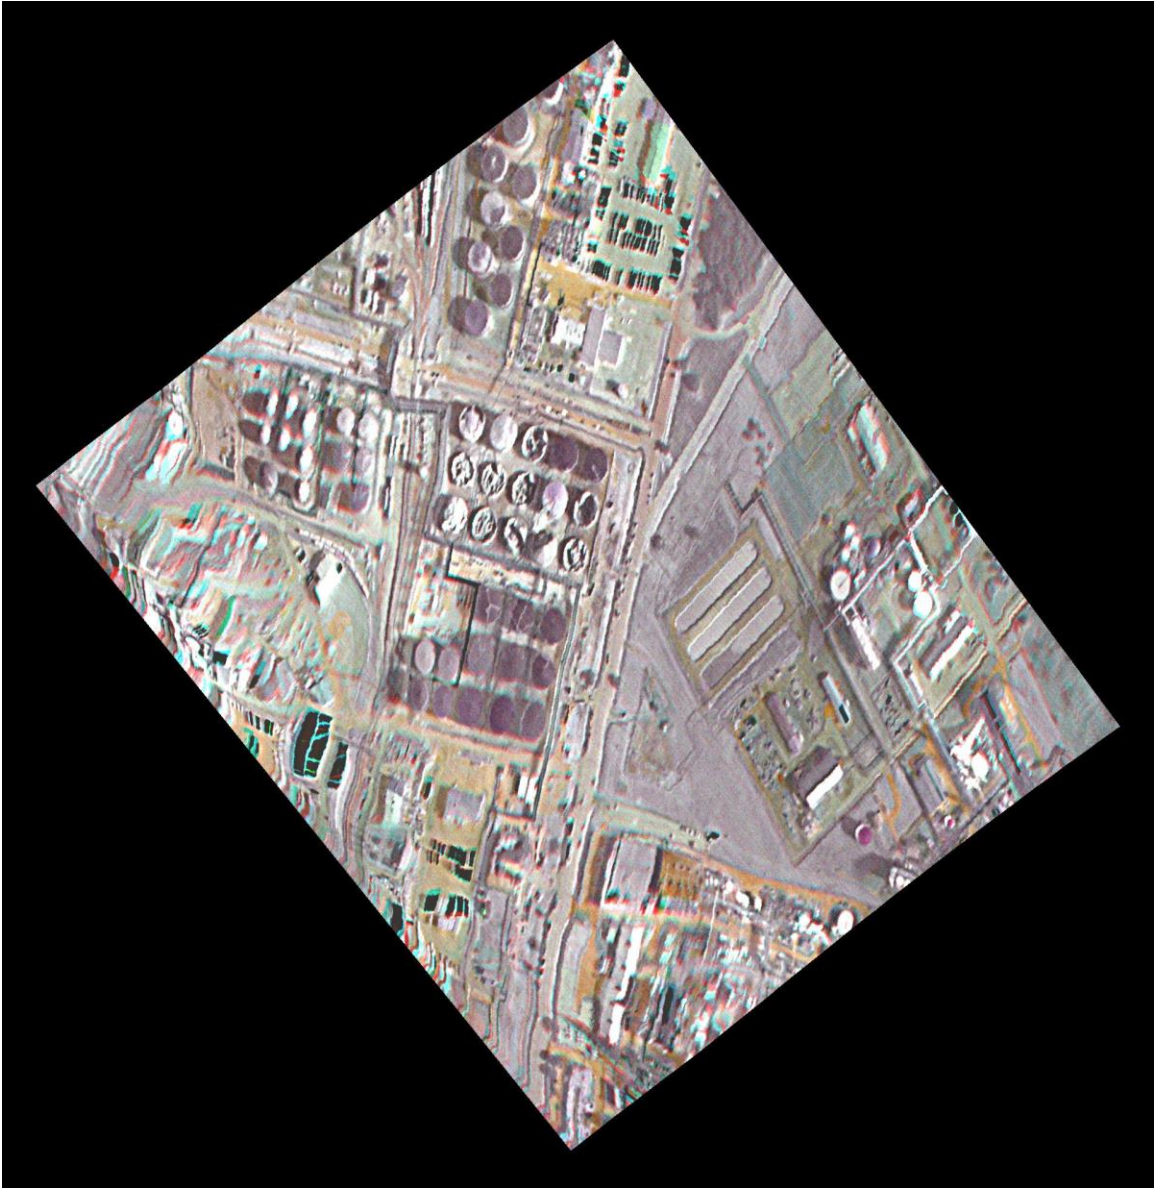
Figure 3: IR image of ITC data for 14 April 2019, Flight 25, Run 2

A total of 2 test and 5 data passes were made in the proximity of the impacted tank farm and also in extended areas surrounding the site and infrared line scanner images were generated for each pass. Figure 3 shows a typical 3-band infrared image obtained from data collected for Run 2. Note that the wave-like distortion was caused by turbulence (rolling) of the aircraft during collection. Analysis of the tank farm area showed no significant thermal contrast other than the cooler tanks in the NE corner of the farm.
